## Community Access Warden report for the Heritage and Open Spaces Committee meeting on 24 June 2025

### Detailed report

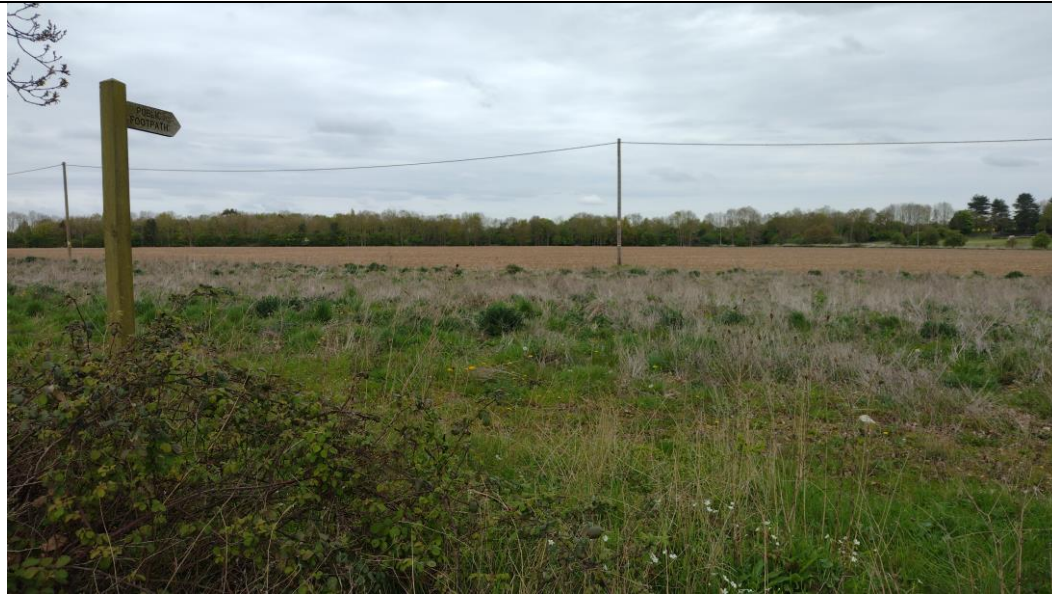
<b><i>Priority with reason</i></b>
<p><b>FP1a</b></p> <p>This path runs south from the A47 to Mattishall Road. There is a fingerpost at the A47 which directs walkers down a set of steps, through a short length of woodland and across an open field to Mattishall Road. A fingerpost is in place there to direct walkers going towards the A47. The field is regularly sown and cropped and often the path has been well made. Of late, this has not been the case and finding the correct route without GPS or excellent map reading skills would be difficult. Walkers going south from the A47 might be able to make out the distant Mattishall Road fingerpost, but those going north have much less to guide them.</p> <p><i>Path walked 23 April 2025</i></p> <p>At the Mattishall Road end, the last 20m or so is rough scrub with no path marked through it. The legal line of the path passes just left of the central pole.</p>	<p><i>The issue of concern is the prolonged and sometimes repeated failure to indicate and make the course of the path. The legal requirement is that where the surface of a path has been ploughed, the occupier shall make good, within 14 days of the first disturbance and within 24</i></p>

*hours of any other disturbance, the surface of the path and indicate the line of the path on the ground to not less than the minimum width (Section 134 Highways Act 1980). This is a summary of the much longer exact wording of the Act.*

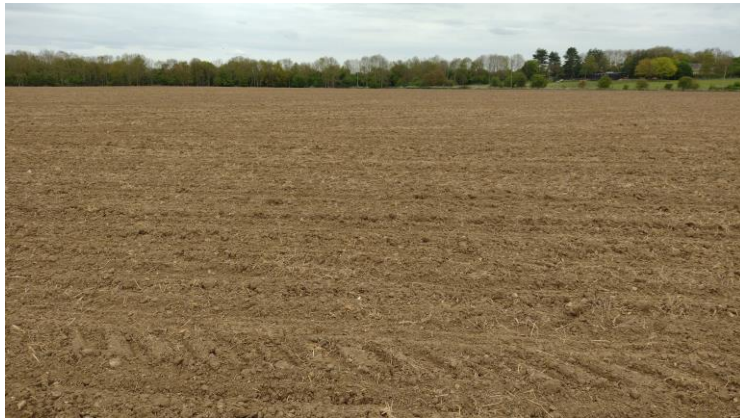
The rest of the field has been fine ploughed, again without the path having been made. The photo below is looking north from just north of the previous photo.

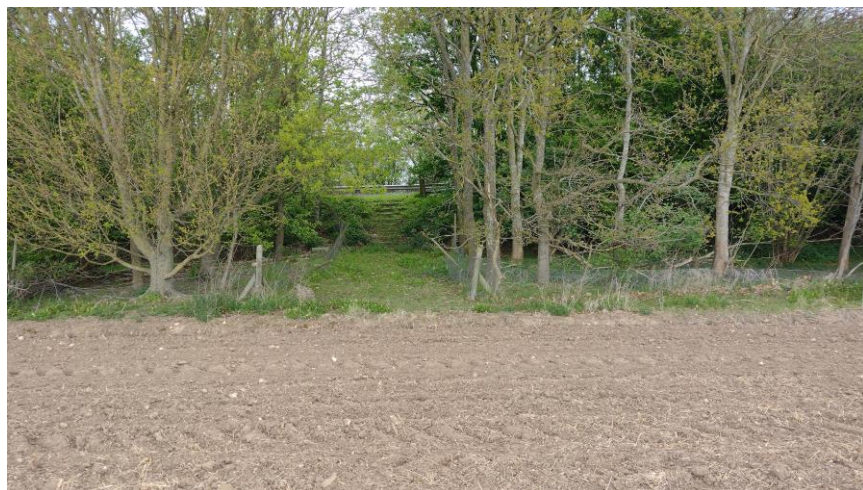
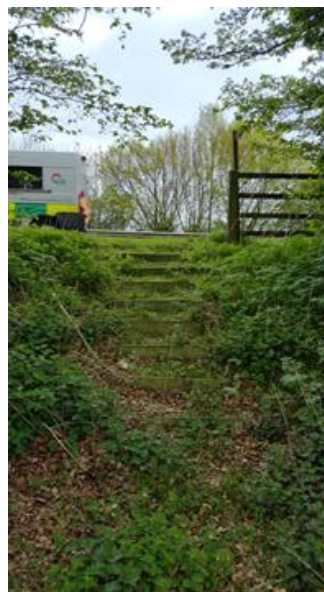
Near the A47, the path runs through a short length of woodland and up steps to the A47 (complete with fingerpost). Note the lack of path leading to this section.

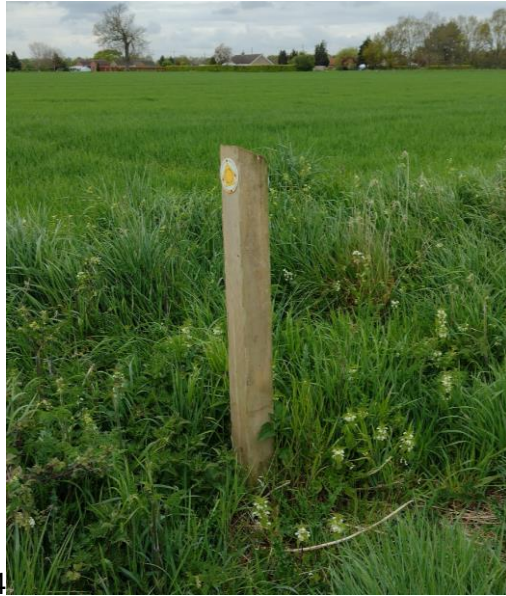
4

Part way along, the path moves across the boundary hedge into the adjacent field. A post and waymark disk indicate this, though the surface hasn't been cleared to make an actual path (4); nor has the field edge surface on the continuing section of path (5, looking north).

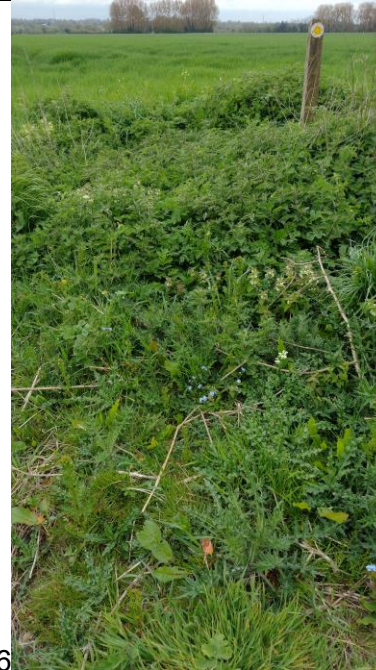
6

Further south, the hedge ends (6, looking south) and the path crosses the field (7 looking south and 8 looking north - the post and disk just visible directly in line with the path).

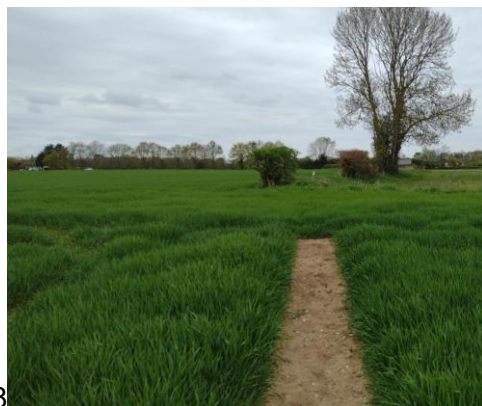
8

Both of these paths cease short of the field edge (8 at north, 10 at south), leaving 3m of crop to cross at both ends.

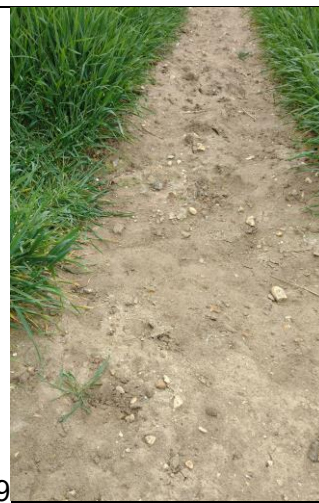
9

The landholder has cleared a narrow strip along the legal line, leaving a soft and uneven surface free of crop which doesn't make easy walking (9). Close by, a parallel set of tractor tyre tracks has consolidated the surface and provides a good walking path.

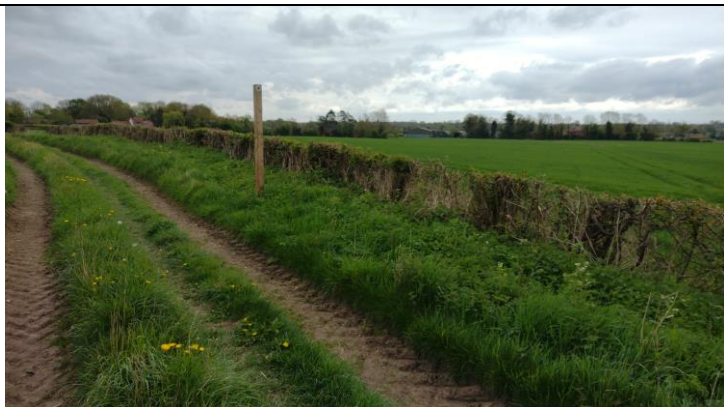
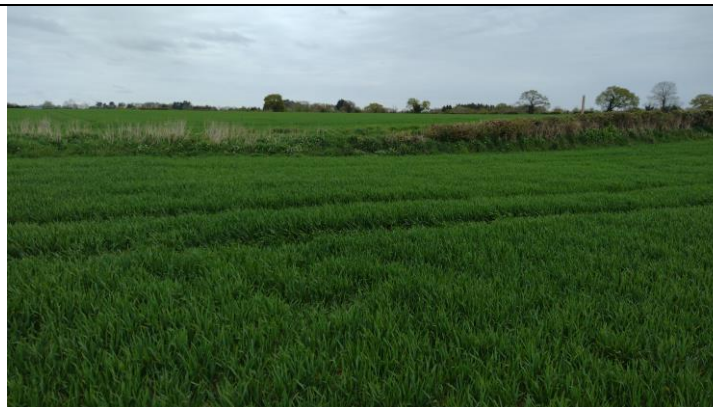
There is a fingerpost marking where the path leaves RB38, but it simply points into the hedge. The first photo is taken from RB28, the second from within the field (the post is just visible towards the right of the picture). As can be seen, there are gaps in the hedge which enable walkers to scramble up from or down into the field, though this would not be viable for users other than walkers.

*The main issue here is the long continuing failure to make and keep this path available to users.*

*Necessary steps are: (1) creating a gap and appropriate access from RB28 onto the legal line of RB3; (2) establishing and maintaining the full length of the line of the path clearly on the ground; and (3) making and signing a proper access from FP26 onto RB3.*

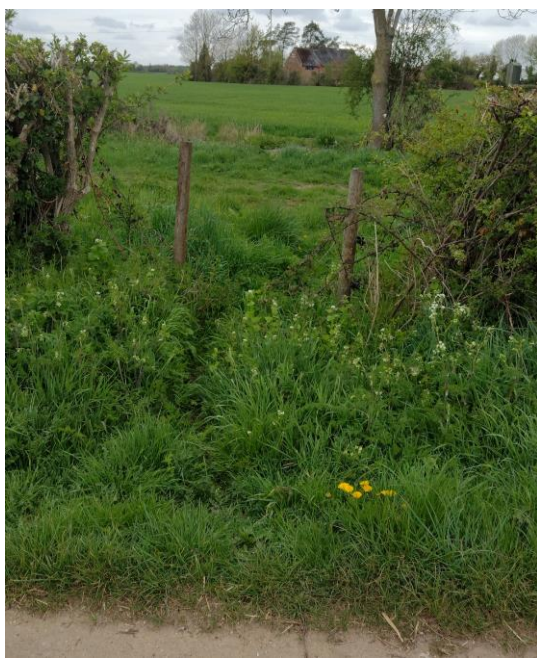
No path had been made across the crop, either from where the fingerpost optimistically directs or from a nearby point where a gap in the hedge gives access to the field. At the far end, after crossing the new culvert, it joins FP26 through a narrow gap in the hedge, though there is no signage. The photo shows the gap and the culvert beyond, looking north.
